Manhole Inspection Summary

Manhole # S37G__023MH

Location Address: **water st**

Cross Street: **commerce st**

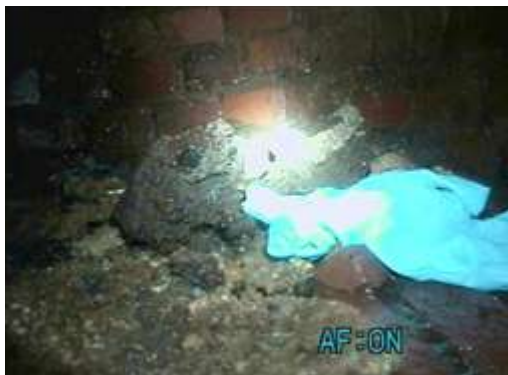
Miscellaneous

bench debris

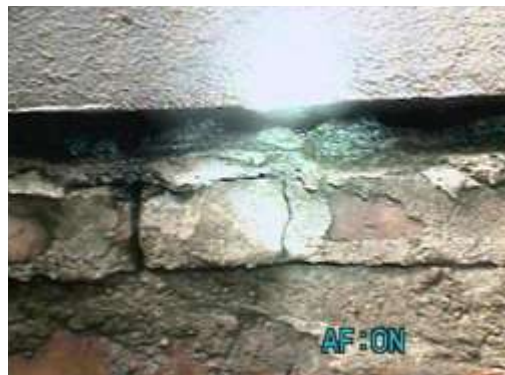
Defect 2

Condition: ☐ Sound ☒ **Cracked** ☐ Root Intrusion ☒ **Loose Brick** ☒ **Deteriorated**

Cracked, Loose Bricks and Deteriorated Chimney, Infiltration

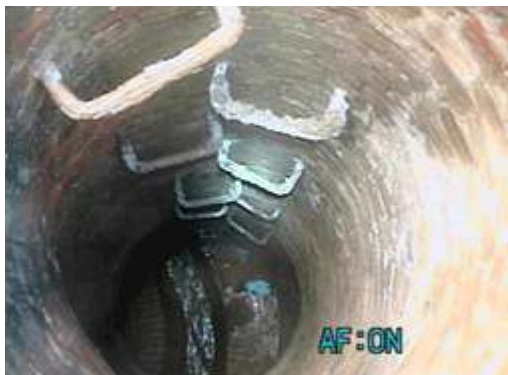
Defect 1

Infiltration: ☐ None ☒ **Joint** ☐ Cracks ☐ Mortar ☐ Roots ☐ Wall

Count: **9** Missing: **0** ☒ **Corroded**

corroded steps, infiltration from corbel joint

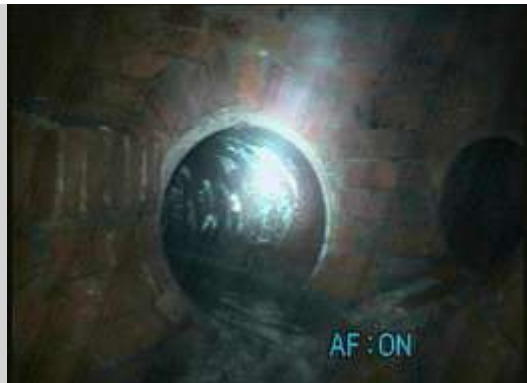
7 O'Clock Inflow

connection under manhole shelf

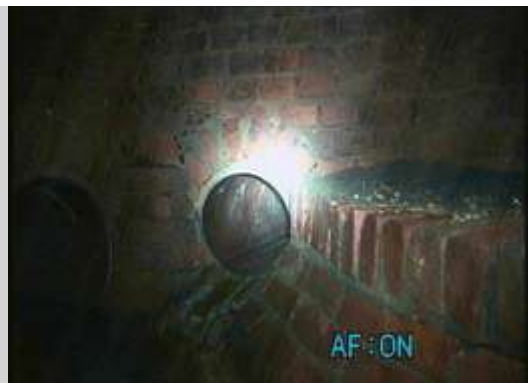
9 O'Clock Inflow

connection under manhole shelf
